Investigating the Reason for Compressor Gearbox Gear Failure in Arfa Iron and Steel Company using Analytical and Fracture Studies

Abstract: Given the application of gears in various industries including steel industries, studying the reasons for failure in gears before reaching the end of their lifetime is of great importance. In this study, a gearbox was investigated which included a gear and a pinion. After four years of use, the teeth of gear and pinion along with the shaft attached to the gear were fractured. The fracture had occurred suddenly and with a lot of noise. The fracture in gear and pinion were in the teeth while the fracture in shaft occurred in the keyway. At the beginning of the study, shaft and gear design equations were used to evaluate the suitability of each of the parts in the system using theoretical equations and then fracture type was determined using fracture studies and the accuracy of analytical results were determined. In the analytical study, the results showed that the fracture is due to improper design for the gear shaft leading to more than one million unites of load on the shaft leading to cracks in the keyway and misalignment between gears causin

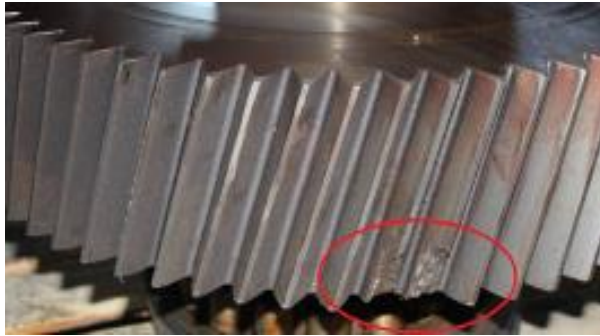
The damage in the gearbox is seen in two neighboring dents (Fig. 2) and another dent a distance away for the previous ones (Fig. 3). One dent on the pinion and two cracks on the shaft on the attachment point are shown in Figs (4 & 5).

Fig. 2 Two neighbouring damaged dents on the gear

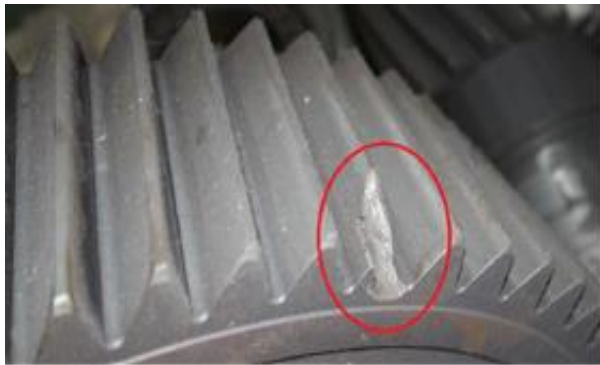
Fig. 3 The lone damaged dent on the gear

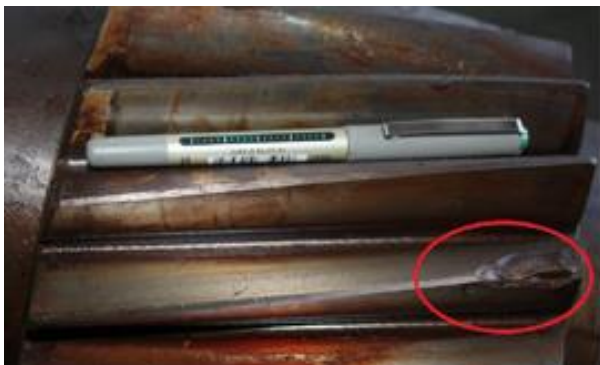
Fig. 4 The damaged dent on the pinion

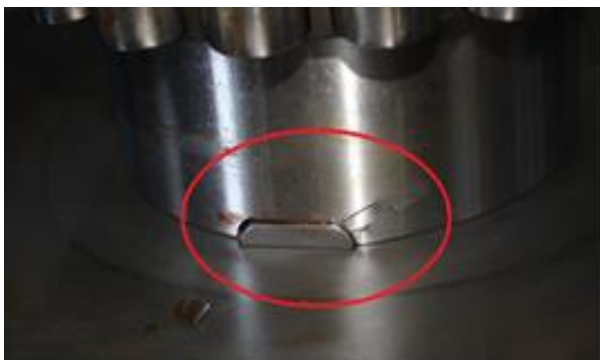
Fig. 5 Damaged location on the shaft

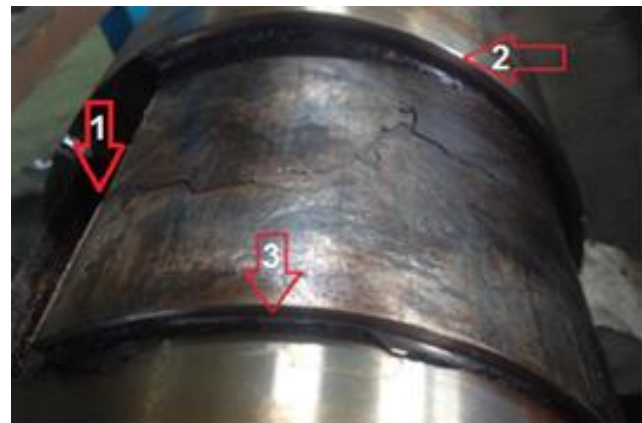
that after the edge of the keyway, maximum stress locations include the half-cycle near gear's support bridge (area 2) and the step near the bearing (area 3). It is necessary to mention that cracks in the shaft (Fig. 28) show the presence of maximum stress at these locations and therefore confirm the results of finite element analysis.

Fig. 28 The fractured gear shaft

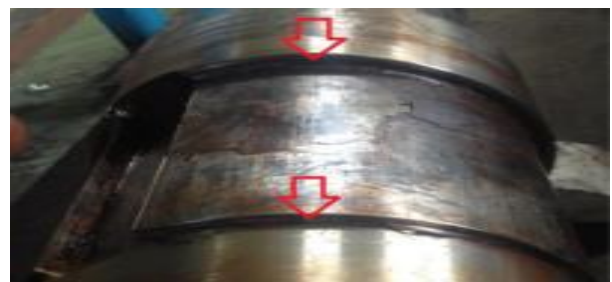
Based on these facts, it can be concluded that fatigue caused by more than one million cycles has led to creation and expansion of cracks on the stress concentration locations (keyway and the location with different shaft diameter, Figs. 38 and 39). Since the length of the key was longer than necessary, instead of damaging to the key, the shaft has been damaged which had led to the fracture. The creation and expansion of cracks on the shaft has led to misalignment of gears with each other, leading to abrasion and finally fracture.

Fig. 38 Cracks at stress concentration points of the diameter change location

Investigating the gearbox showed proper design in gears but intense stress concentration at the location of keyway, due to small diameter. In other words, the shaft diameter should be 270mm. while main shaft diameter was 240mm. Investigating the design of the key revealed its excessive length which led to a safety coefficient of 1.3 and lack of fracture.

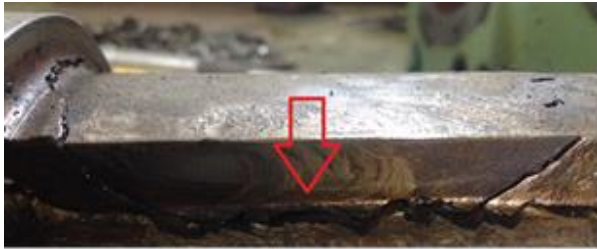
Fig. 39 Crack expansion from stress concentration points in the keyway
