Investigating the Reason for Compressor Gearbox Gear Failure in Arfa Iron and Steel Company using Analytical and Fracture Studies

Abstract: Given the application of gears in various industries including steel industries, studying the reasons for failure in gears before reaching the end of their lifetime is of great importance. In this study, a gearbox was investigated which included a gear and a pinion. After four years of use, the teeth of gear and pinion along with the shaft attached to the gear were fractured. The fracture had occurred suddenly and with a lot of noise. The fracture in gear and pinion were in the teeth while the fracture in shaft occurred in the keyway. At the beginning of the study, shaft and gear design equations were used to evaluate the suitability of each of the parts in the system using theoretical equations and then fracture type was determined using fracture studies and the accuracy of analytical results were determined. In the analytical study, the results showed that the fracture is due to improper design for the gear shaft leading to more than one million unites of load on the shaft leading to cracks in the keyway and misalignment between gears causin

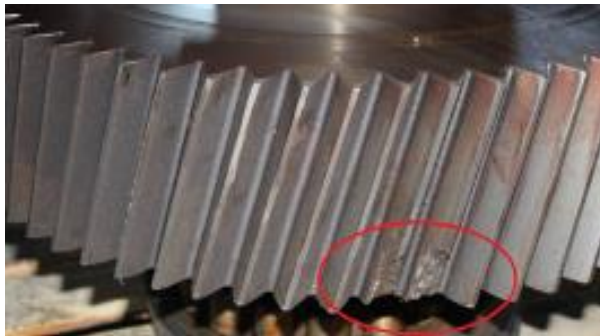
Fig. 2 Two neighbouring damaged dents on the gear

The damage in the gearbox is seen in two neighboring dents (Fig. 2) and another dent a distance away for the previous ones (Fig. 3). One dent on the pinion and two cracks on the shaft on the attachment point are shown in Figs (4 & 5).

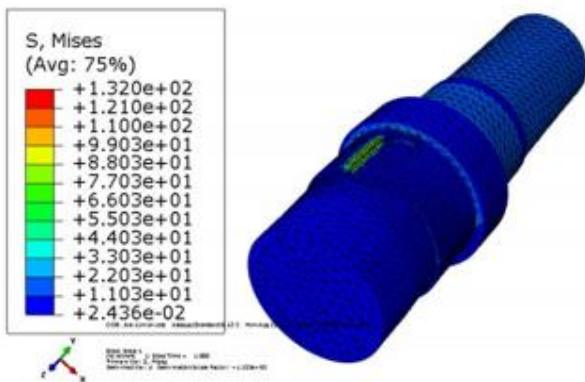
Fig. 30 Stress distribution in redesigned shaft 2

Therefore, based on these results and in the allowed range determined using design calculations, shaft diameter is modified in two stages until the problem is solved. The suitable diameter determined from repeated stress analyses is 251 mm. the results of the final shaft design is shown in Fig. 30. As can be seen, in this shaft, both the stress distribution and maximum stress are reduced.

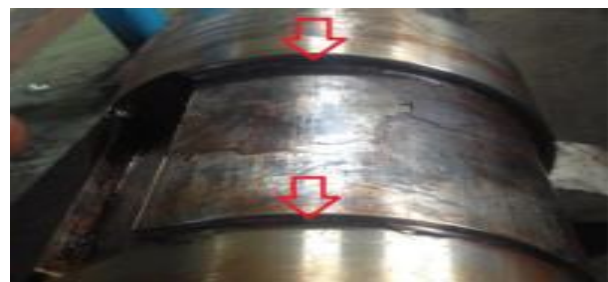
Fig. 38 Cracks at stress concentration points of the diameter change location

Based on these facts, it can be concluded that fatigue caused by more than one million cycles has led to creation and expansion of cracks on the stress concentration locations (keyway and the location with different shaft diameter, Figs. 38 and 39). Since the length of the key was longer than necessary, instead of damaging to the key, the shaft has been damaged which had led to the fracture. The creation and expansion of cracks on the shaft has led to misalignment of gears with each other, leading to abrasion and finally fracture.
